REDUCTION OF MILK FOULING INSIDE PLATE HEAT EXCHANGER USING NANO-COATINGS

Ali Bani Kananeh^{1,*}, Eva Scharnbeck¹, Ulf D. Kück²

¹ *GEA Ecoflex GmbH, Karl-Schiller-Str. 1-3, D-31157 Sarstedt, Germany*

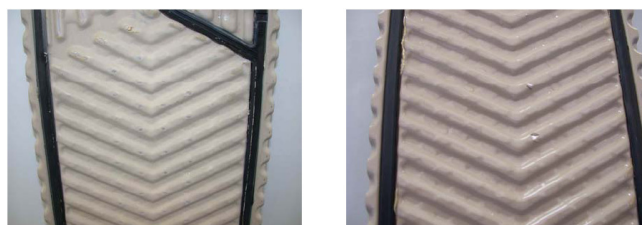
Coated heat exchanger plates with nano-technology

The results showed significant differences between coated and uncoated plates. Three coatings showed a reduced fouling behavior in comparison with the standard stainless steel plates. The electro-polished plates showed also a lower fouling behavior in comparison to the standard stainless steel plates and almost comparable to the coated plates. The cleaning in place (CIP) time was reduced by all coatings: PTFE coated plates down to 10%; coated plates down to 30%; electro polished plates down to 64%.
